### **Maryland Historical Trust**

Maryland Inventory of Historic Properties Number: 67-11-C-567  Name: 1006/Att. 1640 Over Big Enventoried by the Maryland State Highway Administration as part of the Historic Bridge Inventory, and SHA provided the Trust with eligibility determinations in February 2001. The Trust accepted the Historic Bridge Inventory on April 3, 2001. The bridged	
received the following determination of eligibly.  MARYLAND HIST Eligibility Recommended  Criteria:ABCD Considerations Comments:	Eligibility Not RecommendedX
Reviewer, OPS:Anne E. Bruder	
	June 1

NAME AND SHA NO.: 11006	
LOCATION  Road Name and Number: Alt. US 40 Over Big Shade Run  City/Town: Grantsville X vicinity  County: Garrett	
Ownership: X State County Municipal Other	
Bridge projects over: _ Road _ Railway X Water _ Land	
Is bridge located within designated district?: _ yes X no  NR listed district _ NR determined eligible district locally designated _ other Name of District _	
BRIDGE TYPE	
Timber Bridge Beam Bridge Truss-Covered Trestle Timber-and-Concrete	
Stone Arch Bridge	
Metal Truss Bridge	
Moveable Bridge Swing Bascule Single Leaf Bascule Multiple Leaf Vertical Lift Retractile Pontoon	
Met

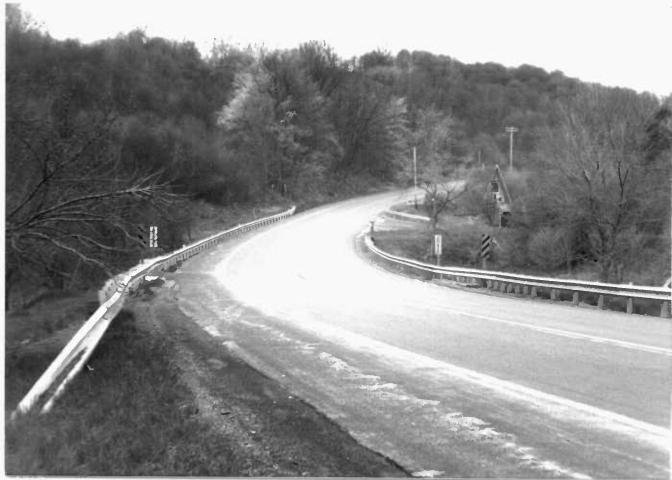
G-II-C-362 BRIDGE NO. 11006

US 40 Alt over Big Shade Run Genrett Co, MD Kin Anderson 5/6/96 SHA East Approach 1 04 4 798-21A

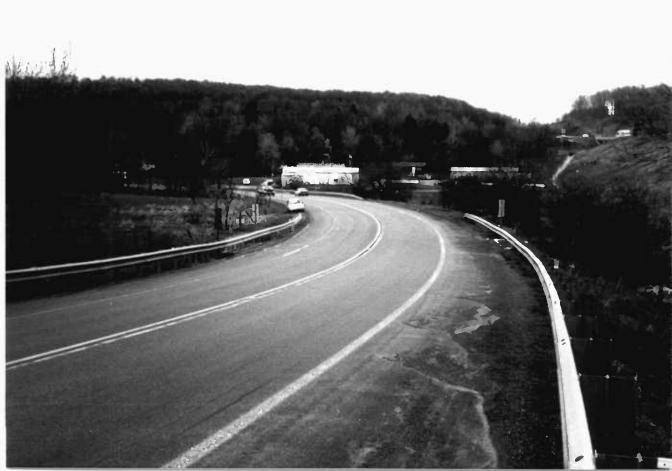
3-II-C-362 BRIDGE No. 11006

US 40 Alt. over Big Shock Run Correct 6. MD Kim Andersa 5/6/96 E, 11A West logprosen Z of 4 798-13A

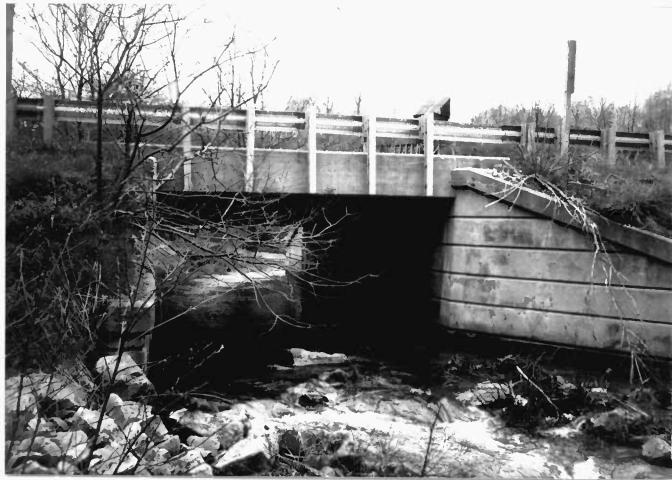
C-JC-362 FRIDGE XW. 11006

US 40 Art over Big Shade Run Gomet Co, MD Kim Anderson 5/6/96 SUA South Heustien (Downstream) 2 of 4 798-14A

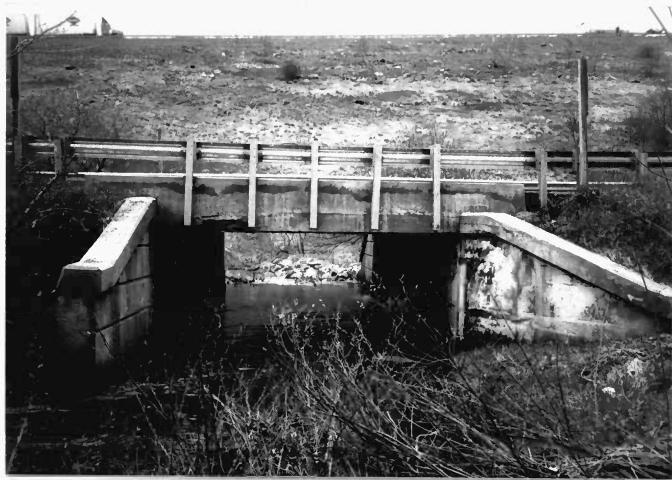
The structure shows signs of spalling, cracking, and exposed, rusted rebar in the north headwall. Recent photographs also show a large vertical crack at the juncture between the northeast wing wall and the east abutment. According to current inspection reports, girders 1 and 7 were repaired at mid-span and the sidewall, backwall and wing walls on the north side have been repaired.

13-11-C-362 BRIDGE NO 11006 US 40 Alt over Big Shade Run Gamet G., MD Kim Anderson 5/6/96 SHA North Elevation (Upstream) 1 of 4 798-171
